**COMPREHENSIVE NESHAP
ASBESTOS SURVEY**

FORMER COMMERCIAL BUILDING

*112 W. Madison Street
Ottawa, IL 61350*

MEC PROJECT #: 14-01-015-INSP

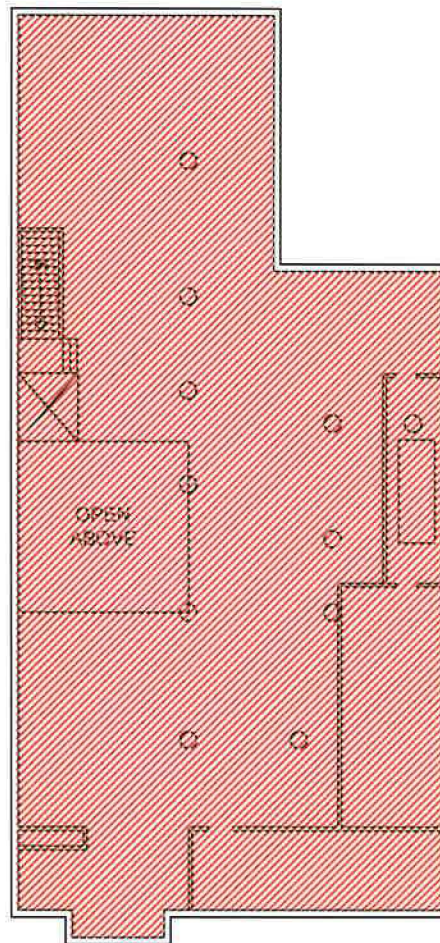
**BASEMENT**

34,200 S.F. & Contamination On Floors & 200 L.F. On Piping

Yes**COMMENTS:**Visible Debris Throughout - All Floors - Heaviest in Basement - Entire Floor
& Items on it Contaminated.

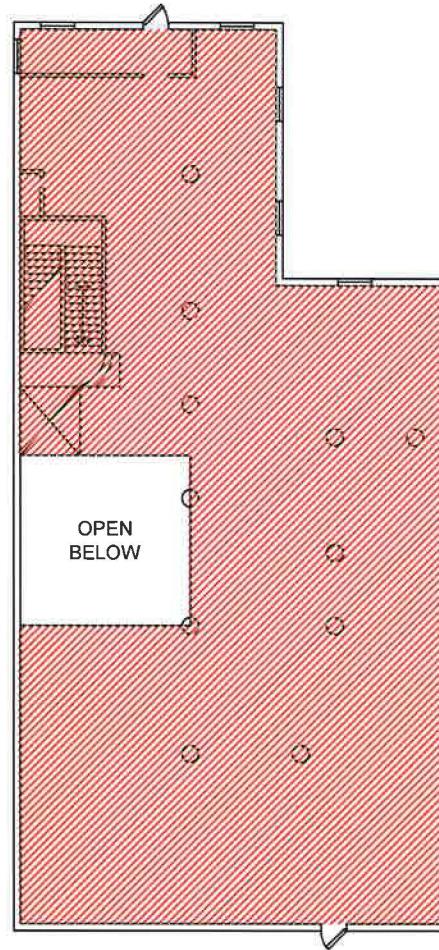
**1ST FLOOR**

COMMENTS:Visible Debris Throughout - All Floors - Heaviest in Basement - Entire Floor
& Items on it Contaminated.

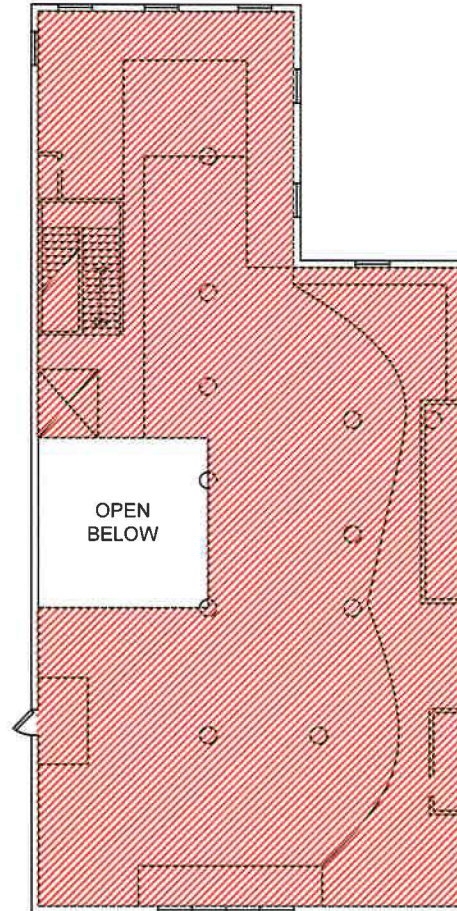
**2ND FLOOR**

COMMENTS:Visible Debris Throughout - All Floors - Heaviest in Basement - Entire Floor
& Items on it Contaminated.

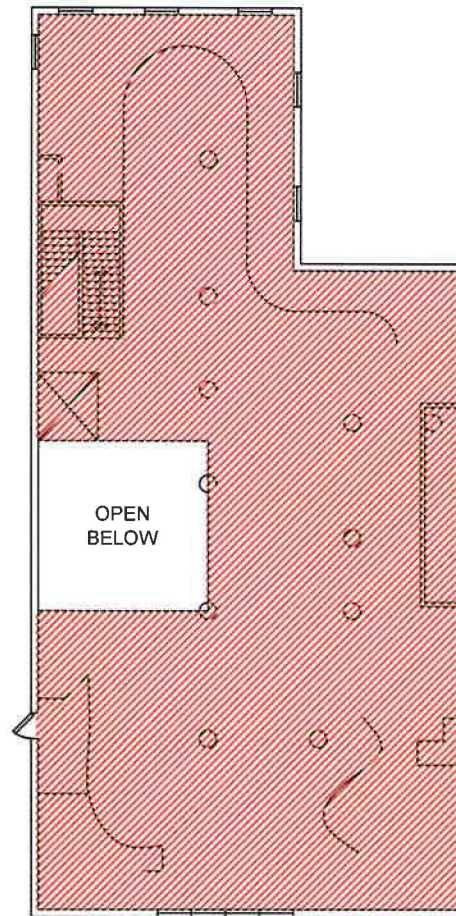
**3RD FLOOR**

COMMENTS:Visible Debris Throughout - All Floors - Heaviest in Basement - Entire Floor
& Items on it Contaminated.

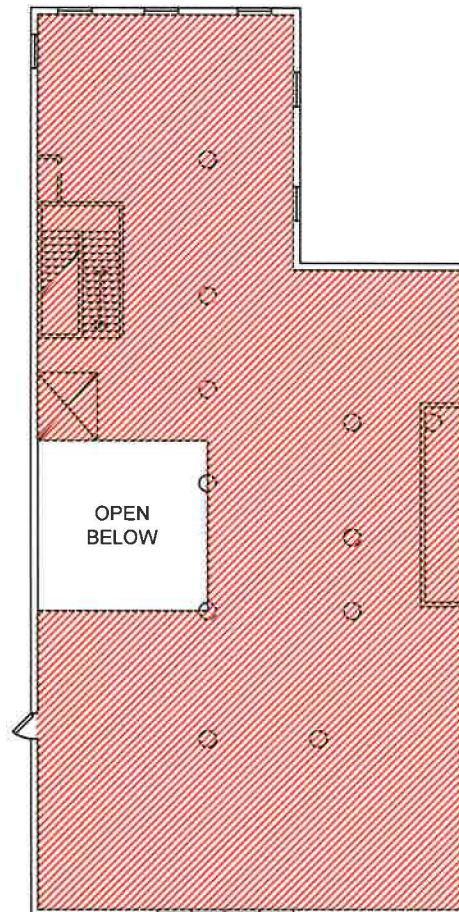
**4TH FLOOR**

COMMENTS:Visible Debris Throughout - All Floors - Heaviest in Basement - Entire Floor
& Items on it Contaminated.

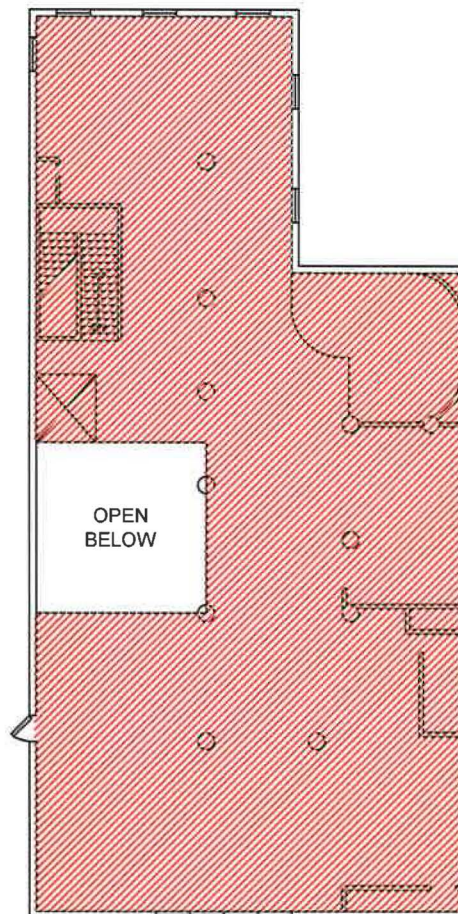
**5TH FLOOR**

COMMENTS:Visible Debris Throughout - All Floors - Heaviest in Basement - Entire Floor
& Items on it Contaminated

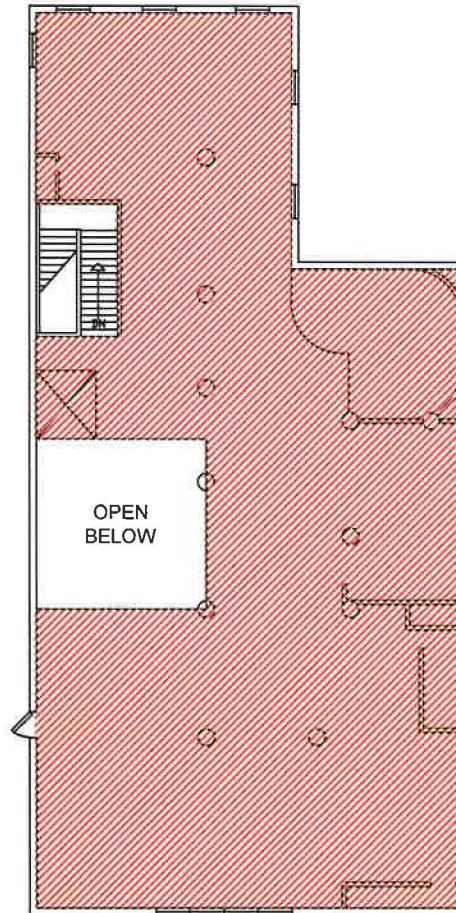
**5TH FLOOR**

Tile Covered Over With Debris - Over Positive Leveling Compound. (MMH)
on Wood Both Tile and Mastic Positive for ACM.

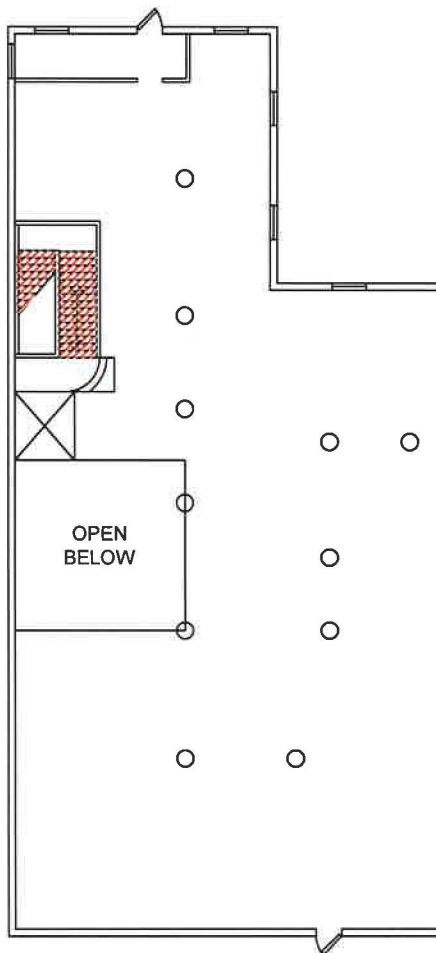
1ST FLOOR

Tile Covered Over with Debris - Over Positive Leveling Compound On Wood. Both Tile & Mastic Positive For ACM.

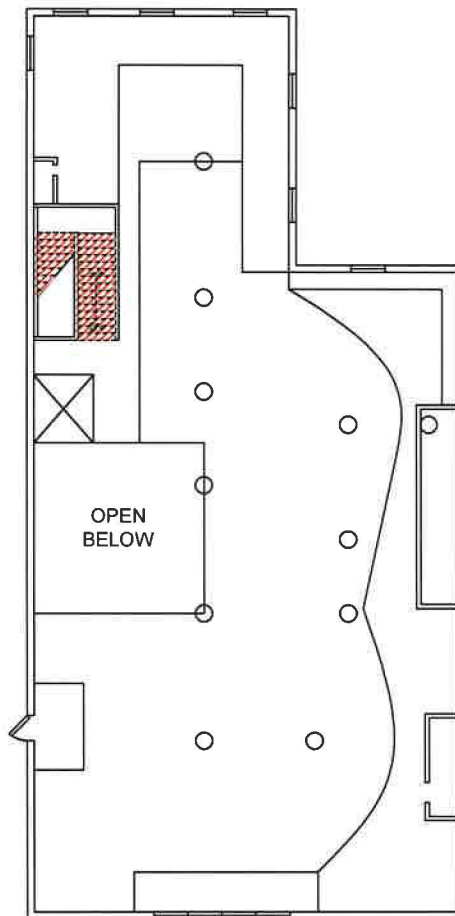
**2ND FLOOR**

Tile Covered Over with Debris - Over Positive Leveling Compound On
Wood. Both Tile & Mastic Positive For ACM.

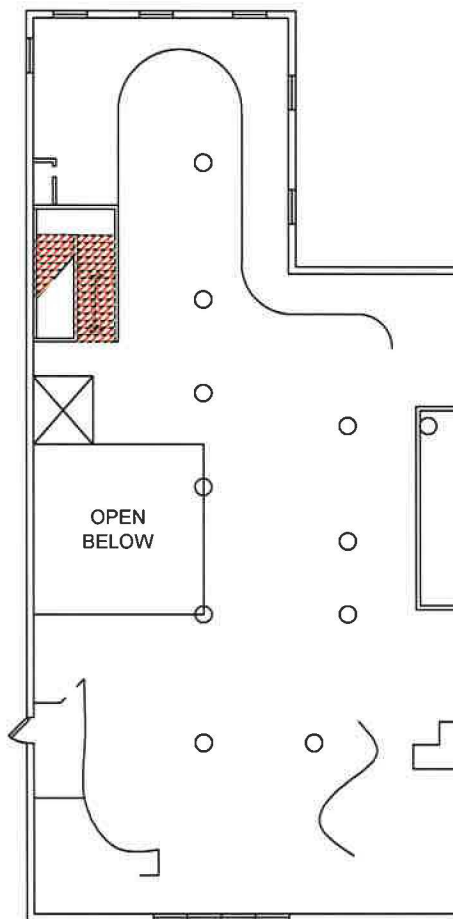
**3RD FLOOR**

Tile Covered Over with Debris - Over Positive Leveling Compound On Wood. Both Tile & Mastic Positive For ACM.

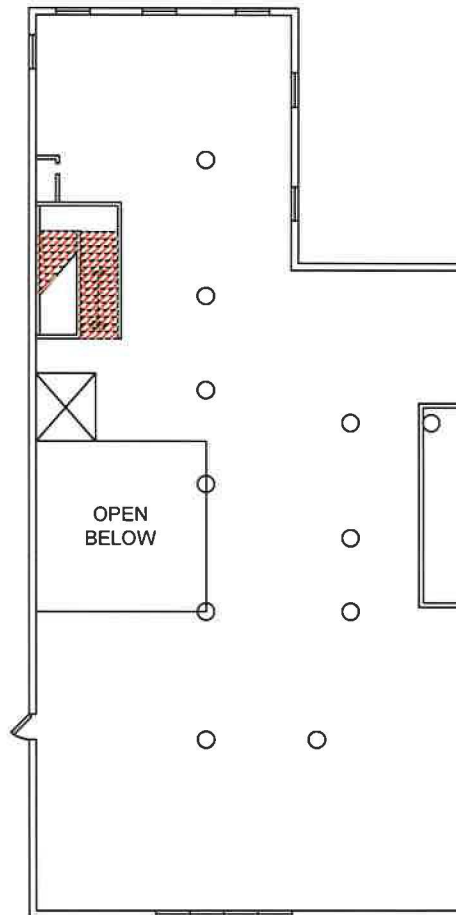
**4TH FLOOR**

Tile Covered Over with Debris - Over Positive Leveling Compound On
Wood. Both Tile & Mastic Positive For ACM.

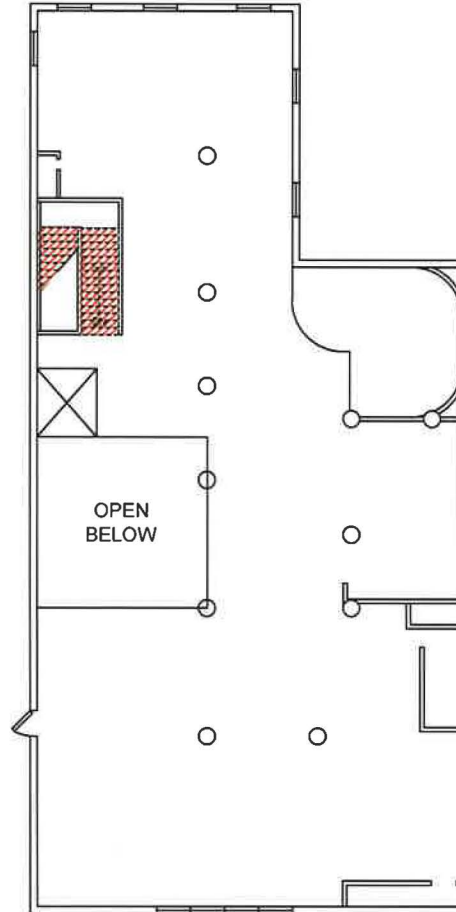
**5TH FLOOR**

Tile Covered Over with Debris - Over Positive Leveling Compound On Wood. Both Tile & Mastic Positive For ACM.

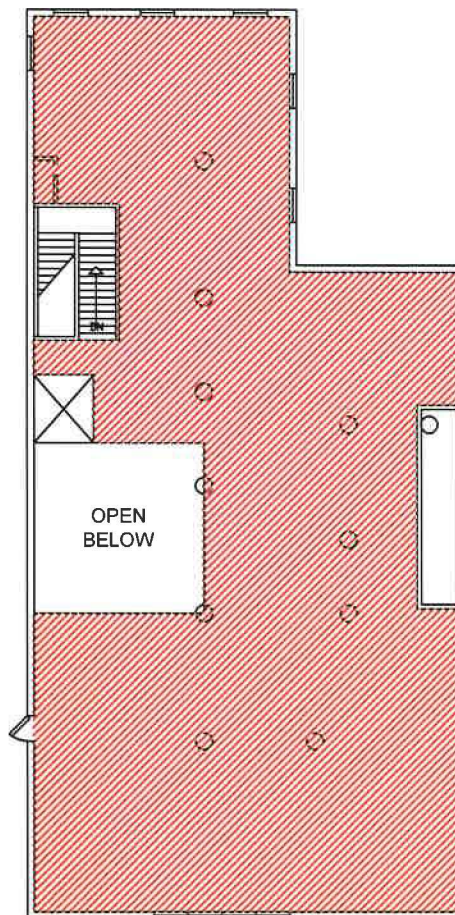
**4TH FLOOR**

MFC

9x9 Floor Tile/Mastic - Reddish Brown

5,200 S.F.

Yes

Tile Covered Over with Debris - Over Positive Leveling Compound on Wood.
Tile Positive, Mastic - Negative.

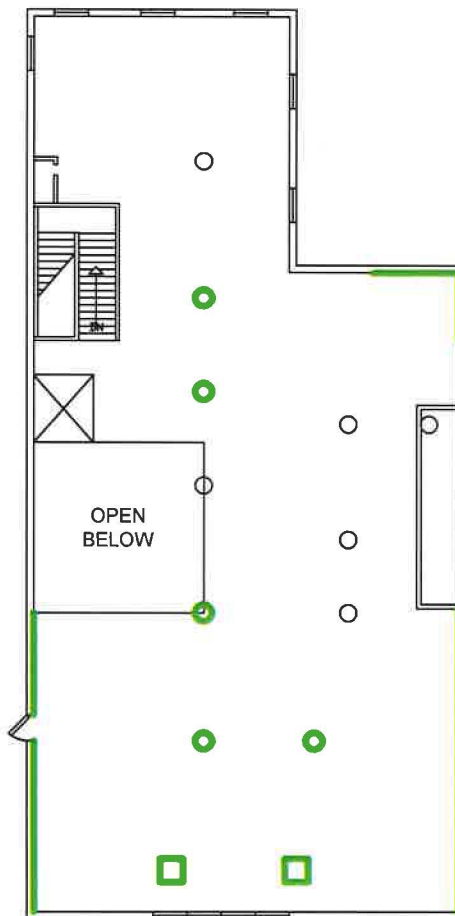
4TH FLOOR

HOMOGENEOUS AREA: MBA
DESCRIPTION: Wallboard/Mastic - Black
QUANTITY ESTIMATE: N/A
ACM Y/N: No

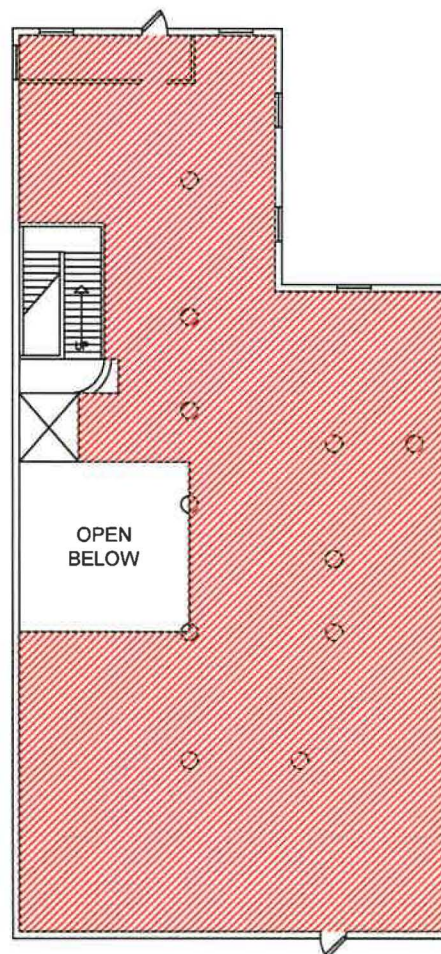
1ST FLOOR

HOMOGENEOUS AREA: MMH
DESCRIPTION: Leveling Compound
QUANTITY ESTIMATE: 26,000 S.F.
ACM Y/N: Yes
COMMENTS: Under Floor Tile on Wood

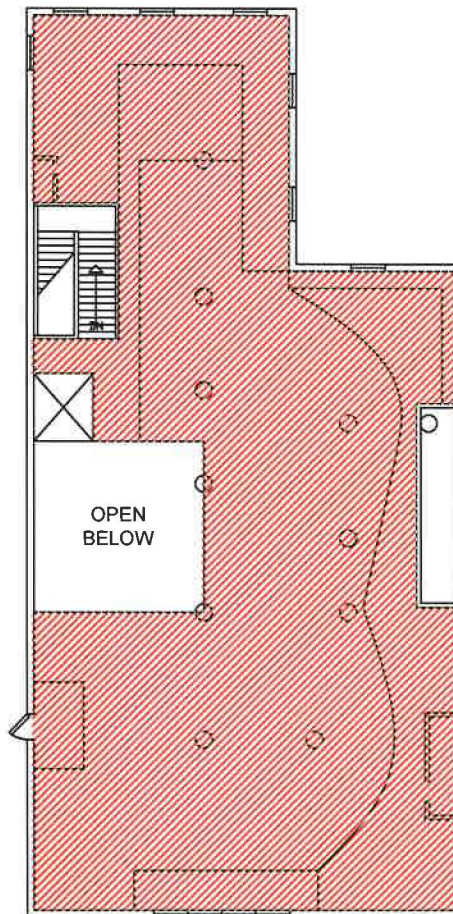
2ND FLOOR

HOMOGENEOUS AREA: MMH
DESCRIPTION: Leveling Compound
QUANTITY ESTIMATE: 26,000 S.F.
ACM Y/N: Yes
COMMENTS: Under Floor Tile on Wood

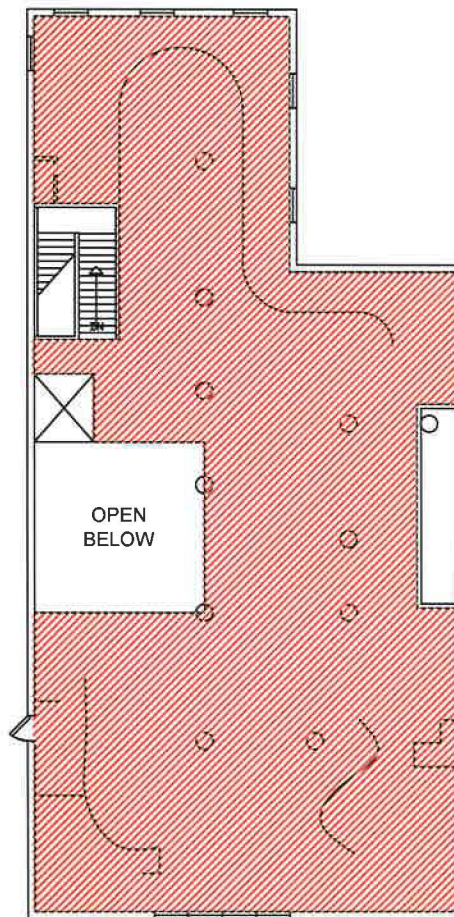
3RD FLOOR

HOMOGENEOUS AREA: MMH
DESCRIPTION: Leveling Compound
QUANTITY ESTIMATE: 26,000 S.F.
ACM Y/N: Yes
COMMENTS: Under Floor Tile on Wood

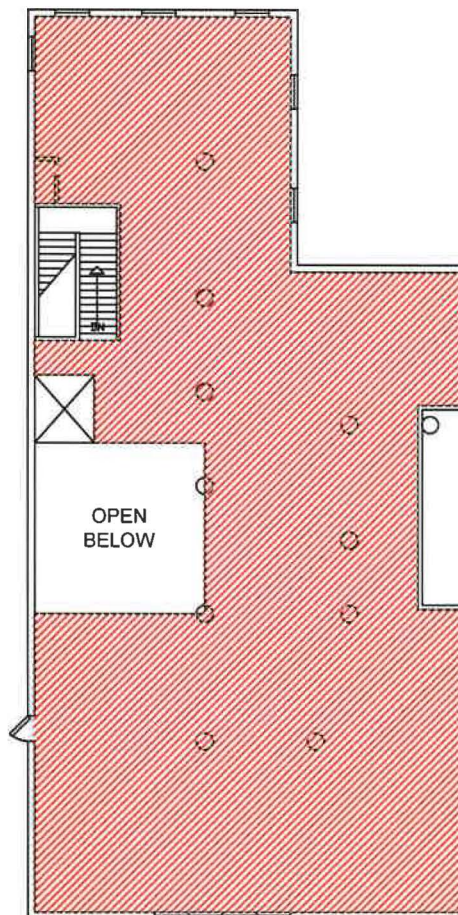
4TH FLOOR

HOMOGENEOUS AREA: MMH
DESCRIPTION: Leveling Compound
QUANTITY ESTIMATE: 26,000 S.F.
ACM Y/N: Yes
COMMENTS: Under Floor Tile on Wood

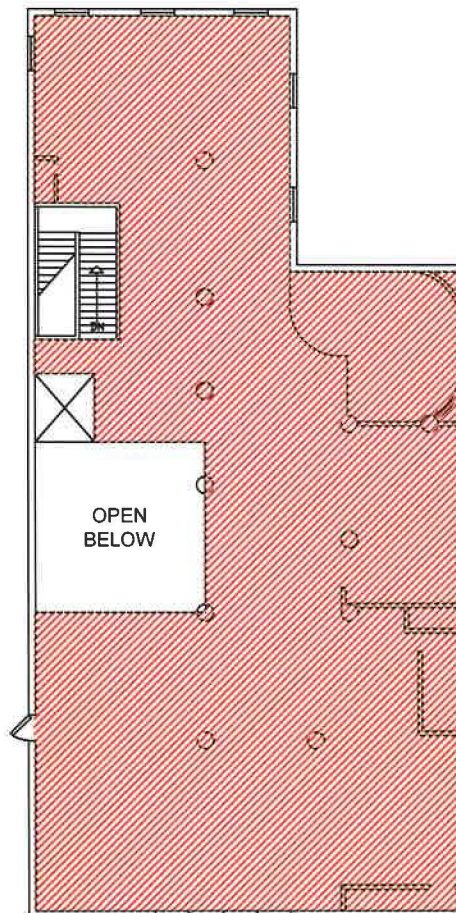
5TH FLOOR

HOMOGENEOUS AREA: MMH
DESCRIPTION: Leveling Compound
QUANTITY ESTIMATE: 26,000 S.F.
ACM Y/N: Yes
COMMENTS: Under Floor Tile on Wood

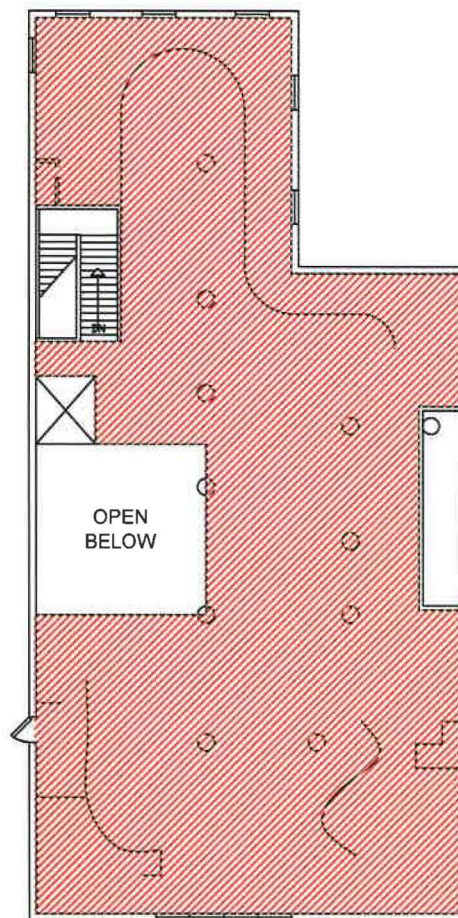
**3RD FLOOR**

MFD

9x9 Floor Tile/Mastic - Dark Brown

5,200 S.F.

Yes

COMMENTS:Tile Covered Over with Debris - Over Positive Leveling Compound
on Wood. Both Tile & Mastic Positive For ACM.

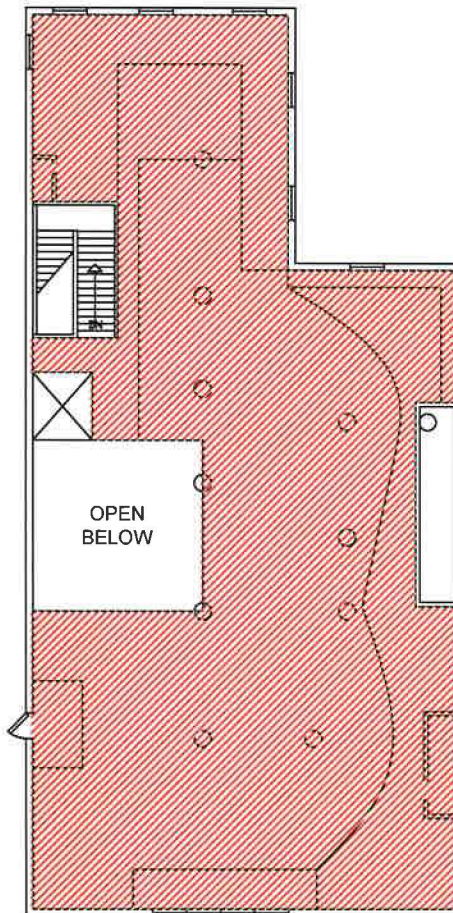
**2ND FLOOR**

MFE

9x9 Floor Tile/Mastic - Tan

5,200 S.F.

Yes

COMMENTS:Tile Covered Over With Debris - Over Positive Leveling Compound On
Wood Tile - Positive, Mastic - Negative

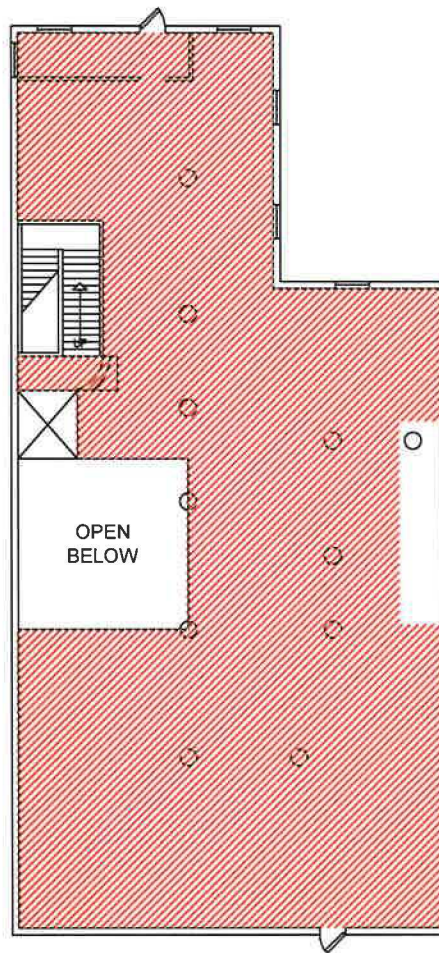
**1ST FLOOR**

MMF

9x9 Floor Tile/Mastic - Black

5,200 S.F.

Yes

Tile Covered Over With Debris - Over Positive Leveling Compound On
Wood & Concrete. Both Tile & Mastic Positive For ACM

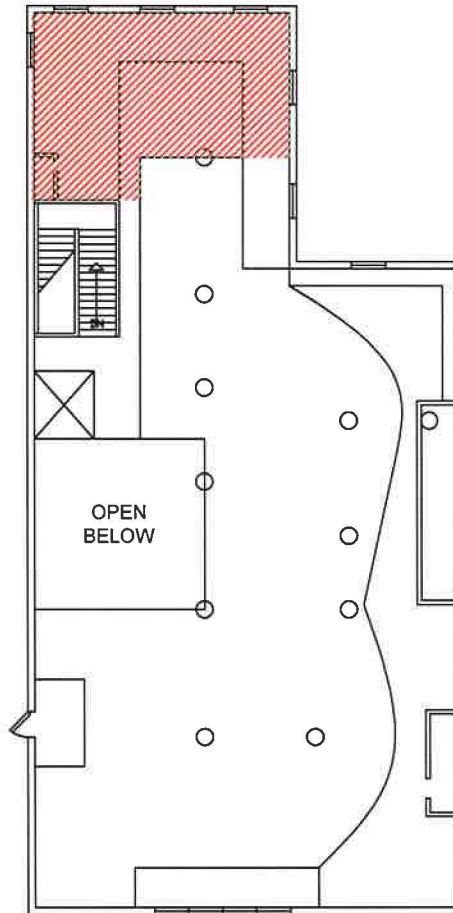
2ND FLOOR

HOMOGENEOUS AREA: TPB
DESCRIPTION: Layered Paper Pipe Insulation/Debris
QUANTITY ESTIMATE: 300 L.F.
ACM Y/N: Yes
COMMENTS: Debris Quantity Included w/TPA

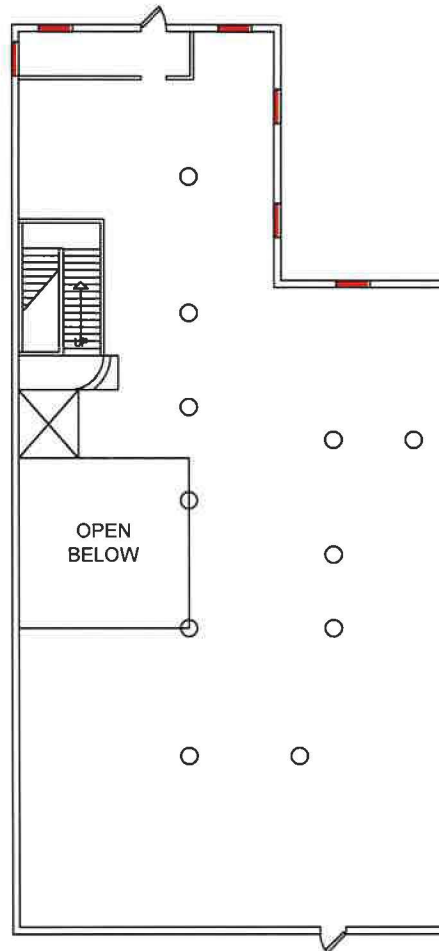
1ST FLOOR

HOMOGENEOUS AREA: MMJ
DESCRIPTION: Exterior Window Glazing
QUANTITY ESTIMATE: 37 Windows
ACM Y/N: Yes

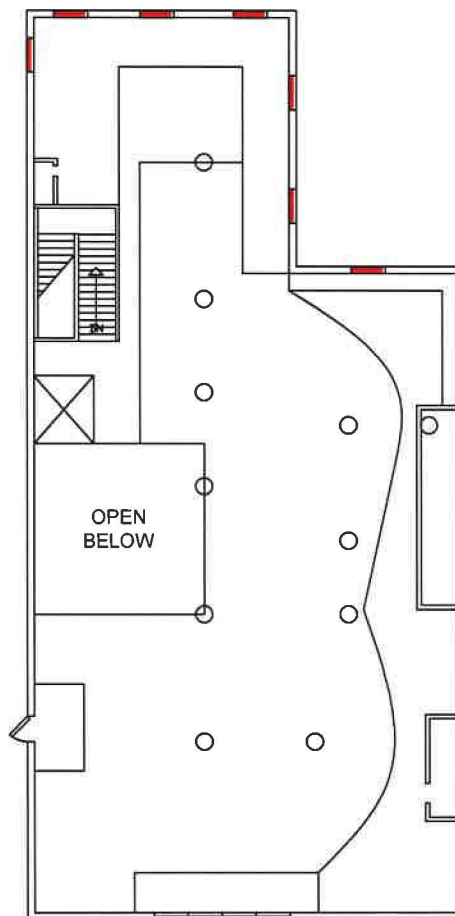
2ND FLOOR

HOMOGENEOUS AREA: MMJ
DESCRIPTION: Exterior Window Glazing
QUANTITY ESTIMATE: 37 Windows
ACM Y/N: Yes

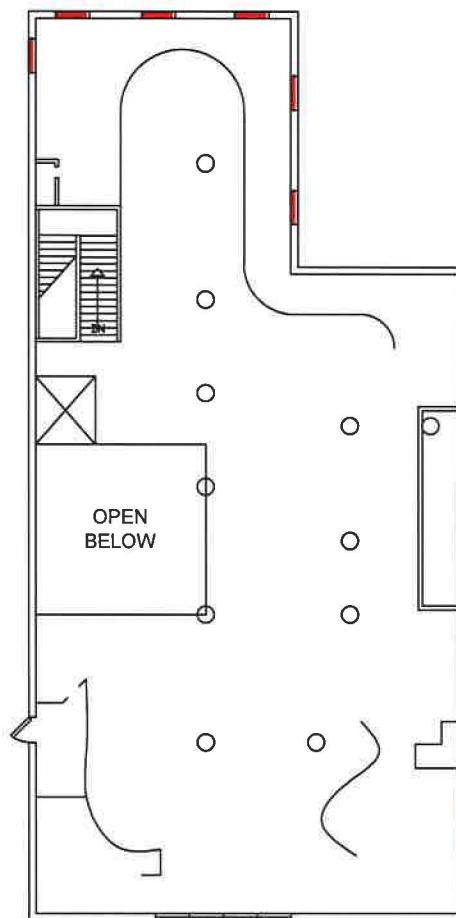
3RD FLOOR

HOMOGENEOUS AREA: MMJ
DESCRIPTION: Exterior Window Glazing
QUANTITY ESTIMATE: 20 Windows
ACM Y/N: Yes

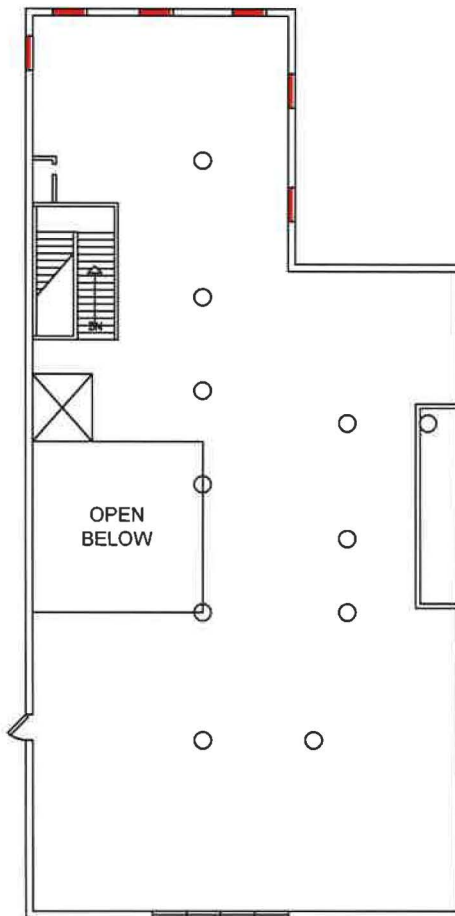
4TH FLOOR

HOMOGENEOUS AREA: MMJ
DESCRIPTION: Exterior Window Glazing
QUANTITY ESTIMATE: 37 Windows
ACM Y/N: Yes

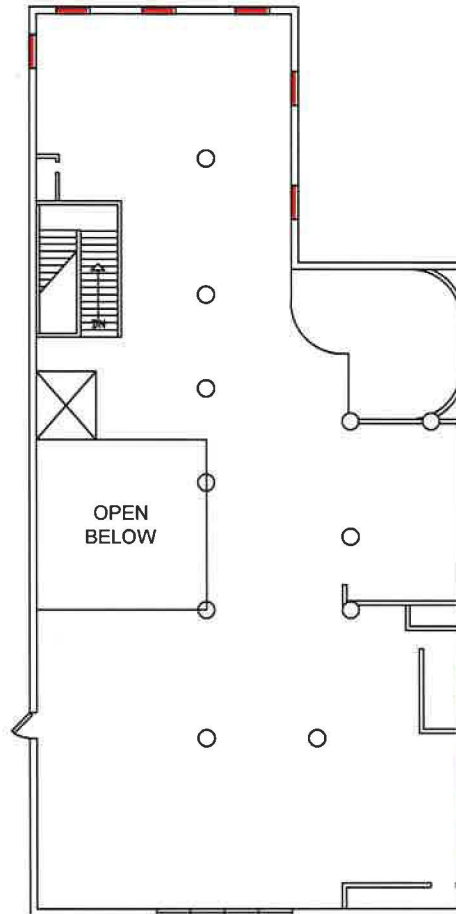
5TH FLOOR

HOMOGENEOUS AREA: MMJ
DESCRIPTION: Exterior Window Glazing
QUANTITY ESTIMATE: 37 Windows
ACM Y/N: Yes

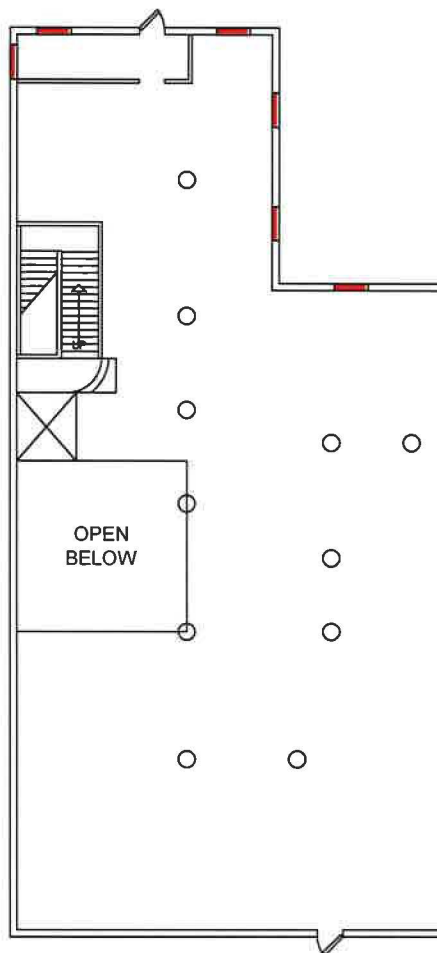
1ST FLOOR

HOMOGENEOUS AREA: MMK
DESCRIPTION: Exterior Window Caulking
QUANTITY ESTIMATE: 800 S.F.
ACM Y/N: Yes

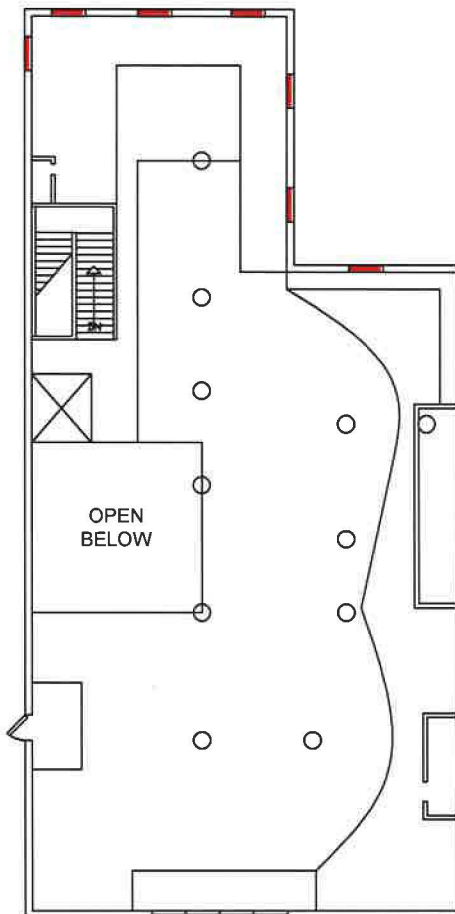
2ND FLOOR

HOMOGENEOUS AREA: MMK
DESCRIPTION: Exterior Window Caulking
QUANTITY ESTIMATE: 800 S.F.
ACM Y/N: Yes

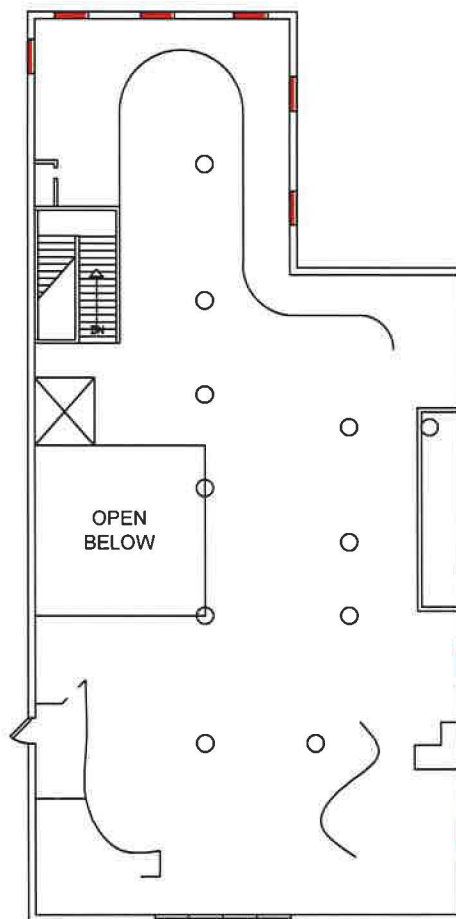
3RD FLOOR

HOMOGENEOUS AREA: MMK
DESCRIPTION: Exterior Window Caulking
QUANTITY ESTIMATE: 800 S.F.
ACM Y/N: Yes

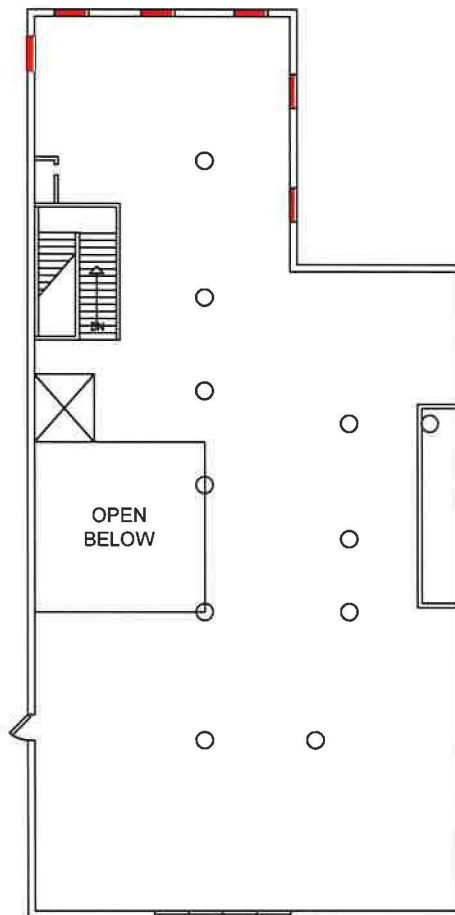
4TH FLOOR

HOMOGENEOUS AREA: MMK
DESCRIPTION: Exterior Window Caulking
QUANTITY ESTIMATE: 800 S.F.
ACM Y/N: Yes

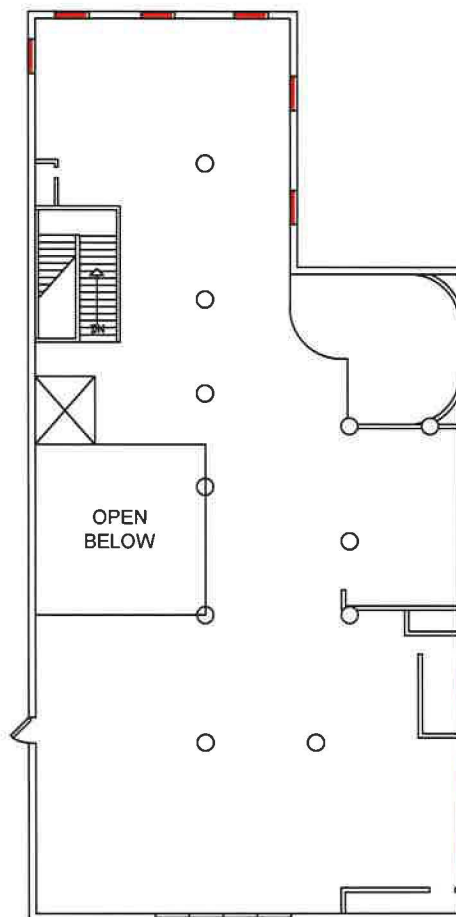
5TH FLOOR

HOMOGENEOUS AREA: MMK
DESCRIPTION: Exterior Window Caulking
QUANTITY ESTIMATE: 800 S.F.
ACM Y/N: Yes

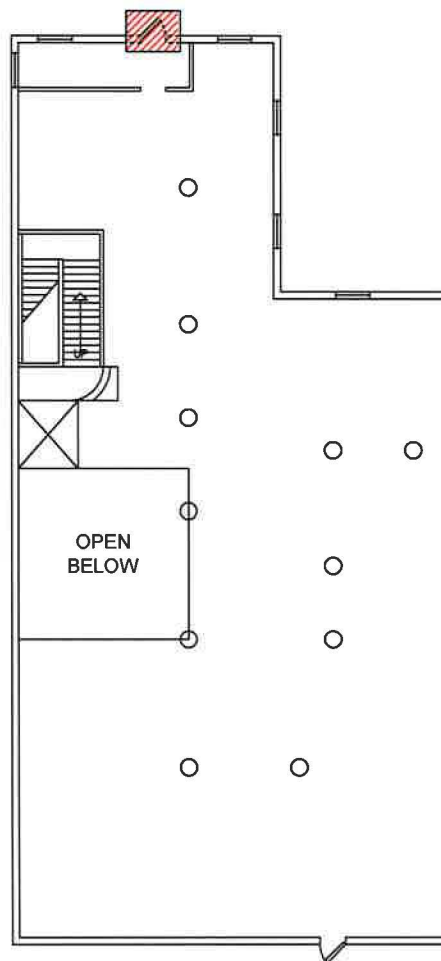
1ST FLOOR

HOMOGENEOUS AREA: MML
DESCRIPTION: Exterior Door Caulking
QUANTITY ESTIMATE: 50 S.F.
ACM Y/N: Yes

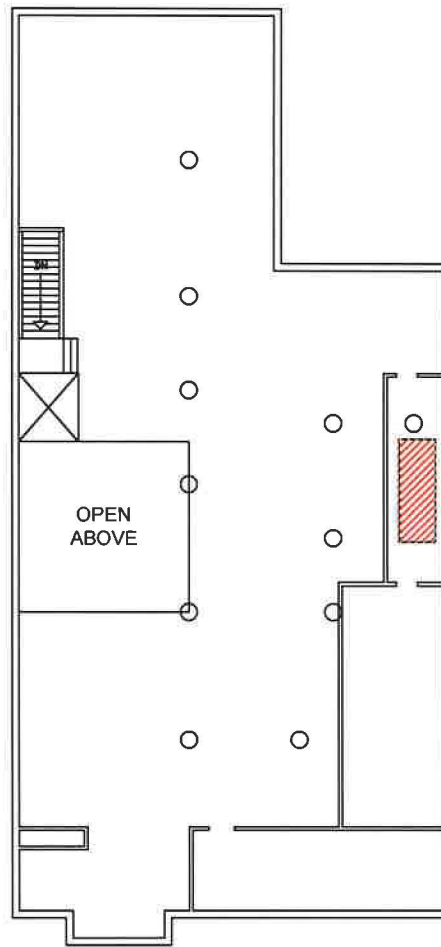
**BASEMENT**

Assumed**COMMENTS:**

Material To Be Sampled Prior To Design/Abatement
